# Prepare to Powder Coat and Put Off the White Stuff

Six preliminary steps can help fight off long  
And short-term corrosion.

# The survey says, . . .

## “Marine grade castings!”

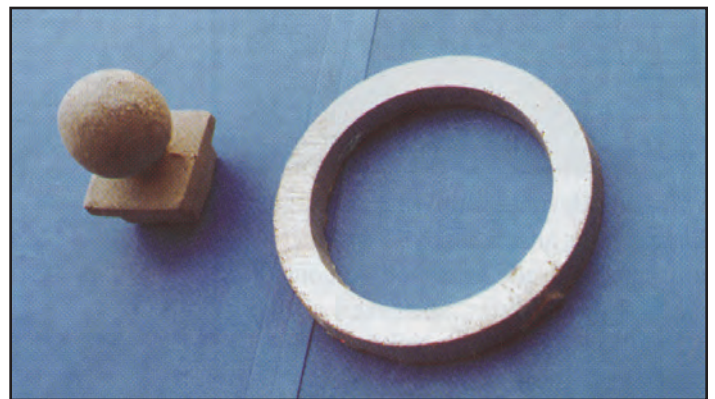
*In the above example, the ball cap with the dull white corrosion was made with a standard aluminum casting alloy. The ring shown was made with a marine-grade alloy and shows no corrosion. It has retained its metallic shiny surface. Both samples were placed together in a chlorine corrosive environment.*

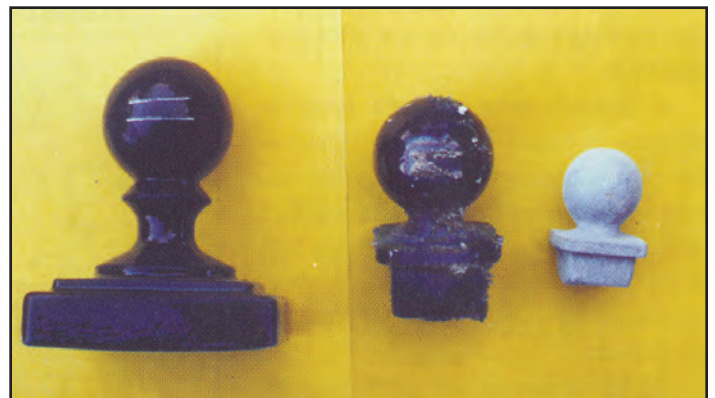
*These samples were placed in a severe chlorine atmosphere to replicate a corrosive environment. The sample on the right is a typical casting showing a white-chalky surface. The center powder coated sample shows corrosion that has penetrated from the inside out of a typical casting. The marine-grade ball aluminum cap on the left shows no corrosion. Even with two saw cuts that were put through the coating and into the ball prior to the corrosive environment, the marine-grade metal did not corrode under the powder coat nor did the coating flake off*

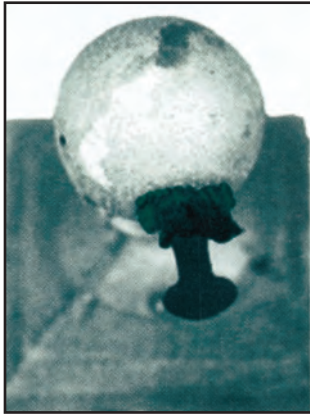
*Left: Dissimilar metals in almost any form can cause severe corrosion. The green area shows severe galvanic corrosion caused by a marine-grade aluminum ball cap attached to a stainless steel bolt.*

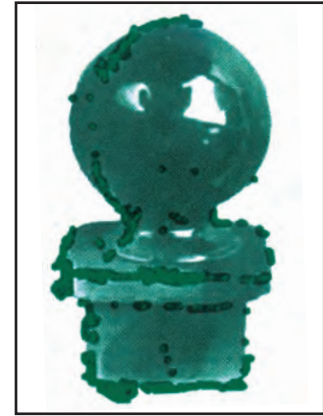
*Right: This ball plug was made with a standard casting alloy, degassed and double coated. The ball exhibits few bubbles but even the double powder coating did not prevent corrosion from penetrating where the coating had been thinly applied. Green speckles show corrosion penetration.*

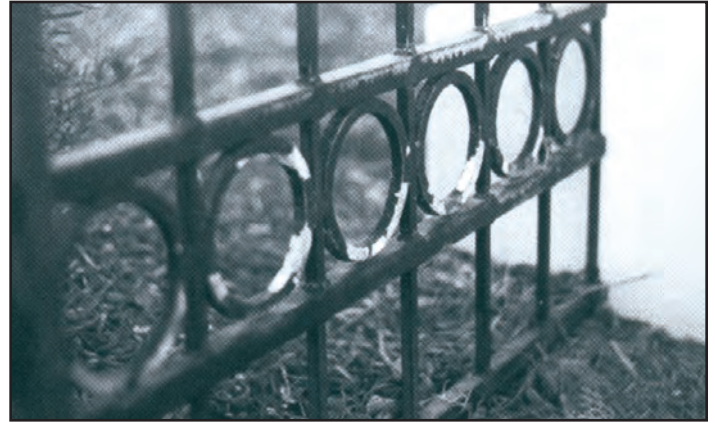
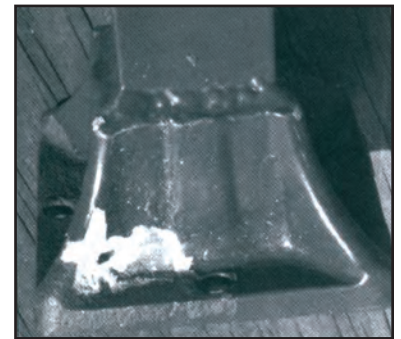
*Below and right: White corrosion has deteriorated the powder coating on the floor flange below and on the metal rings of this cast iron gate.*

I have seen castings on a gate application where the coating on cast aluminum spear finials was in excellent shape but only 24 inches lower on the same picket the cast aluminum collars were badly corroded with the powder coat flaking off. It was difficult to determine which of the many initial steps had been adequate for the finial but inadequate for the collar. Note the photographs on this page showing actual job applications where the powder coat process proved to be inadequate.

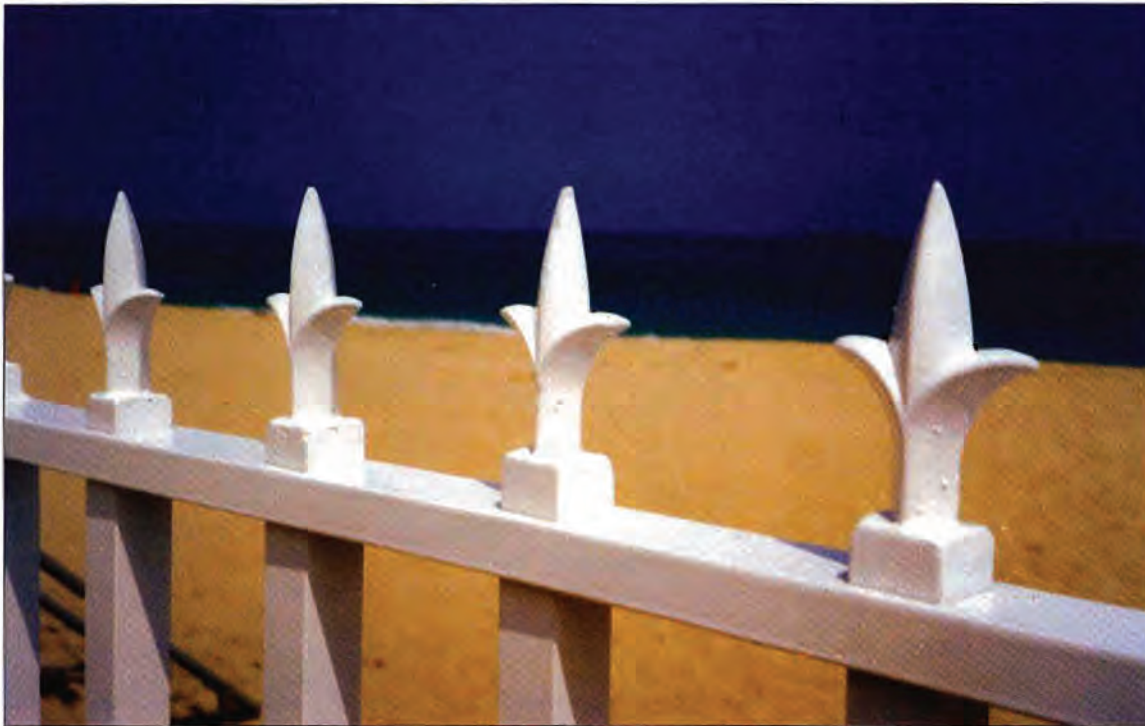
These spear points illustrate the coherent coating of marine grade castings in excellent condition after one year on the beach.

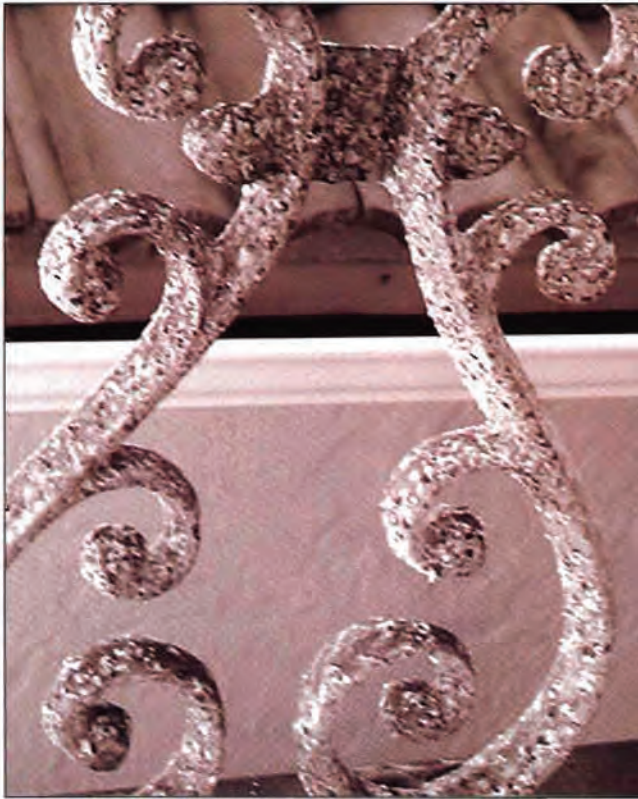
**This scroll casting is not marine grade. It shows severe white corrosion after only 18 months in its ocean environment in Sarasota, FL. No coating remains.**

Flaking and peeling occur on regular aluminum because air penetrates through the coating and corrodes the base metal. The devastation of the coating can occur rapidly when the job site is next to the ocean. Or it can take a much longer period of time in a more temperate climate. Either way, however, the castings will eventually show signs of corrosion. The scroll casting pictured at the top of this page has been on the ocean only 18 months and shows

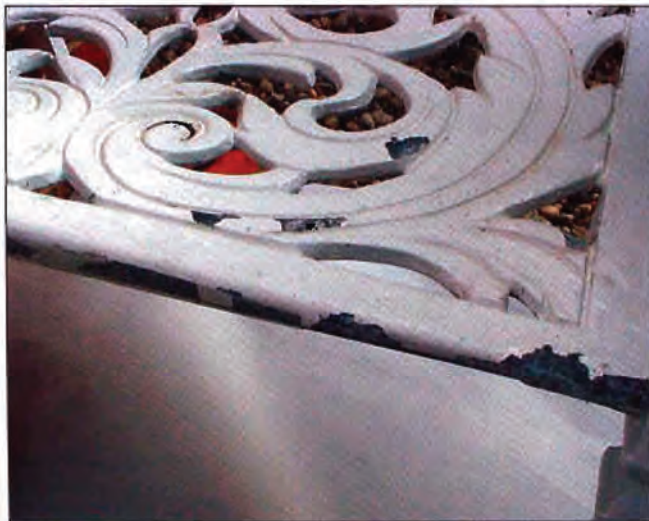
**This 12-year-old aluminum furniture in Dallas, TX, is also not marine grade. Even though it is not in a harsh marine environment, its powder coat is peeling and corrosion appears.**

almost complete disintegration; whereas the aluminum furniture (pictured below it, bottom of page 29) is located in the more moderate environment of Dallas, TX. In this less harsh environment the aluminum held off significant corrosion for 10 years. The furniture has now been in the weather 12 years.

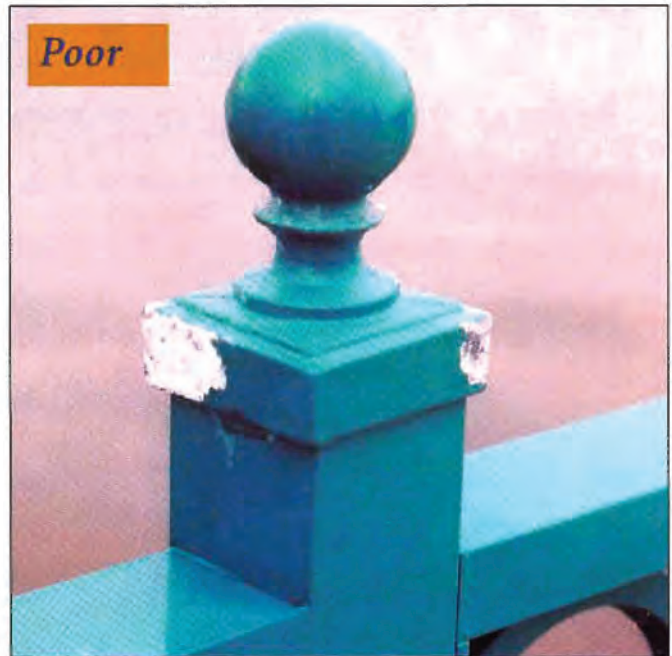
**This 2" ball cap is not marine grade. It shows chalk corrosion and flaking (starting at corners) after four years on the Indian River in Vero Beach, FL.**

Typical corrosion of non-marine aluminum castings is shown at left. The ball cap has been near the ocean for four years and shows the corrosion on the corner edges where only a thin layer of coating might have been applied. This edge with a thin coating enables the salt air to penetrate here first and begin the corrosion peeling action. The root cause of the white chalk aluminum corrosion is the residual amounts of copper that create a galvanic reaction with the aluminum base material.

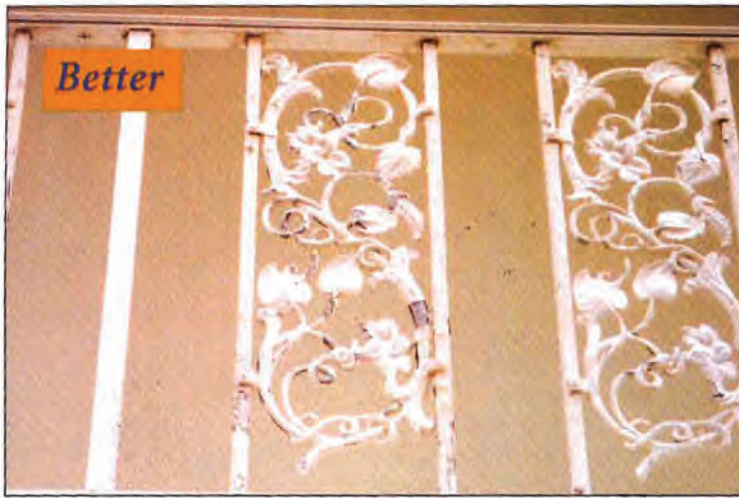
**This flower panel in West Palm Beach, FL, shows flaking because of a poor coating job. But its marine grade castings are still shiny and coherent after eight years.**

Even the use of virgin metal with the correct marine grade chemistry, however, cannot cure the faults of a poor coating application. Pictured at the top of page 32 is a handrail installed near the ocean in Palm Beach, FL. For eight years the castings have been directly exposed to the wind and spray of the ocean. However, they are still shiny and coherent. This shiny and coherent surface indicates no galvanic corrosion has occurred as the marine metal has successfully resisted the salt air. But because of the

poor powder coating application, the net effect is still a poor looking rail. Compare this picture at left with the non-marine grade aluminum castings that have been on the ocean only 18 months (top of page 29). Marine grade castings on the ocean eight years with no corrosion pictured at left show the value of the proper base metal. Again, however, even the marine grade metal could do nothing to improve the original poor powder coating.

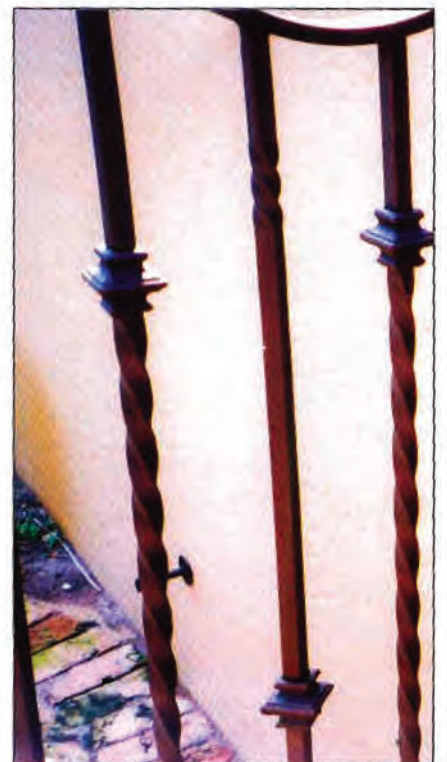
**This aluminum rail with marine grade aluminum cast collars also shows a coherent coating in excellent condition after three years on Florida's Intracoastal Waterway.**

A recent on-site survey of many copper-free marine grade castings that have been on the ocean between one and 3½ years shows the excellent results of combining marine grade castings with good powder coating applications. Shown below and on page 34, the castings are coherent and show no signs of corrosion or flaking.

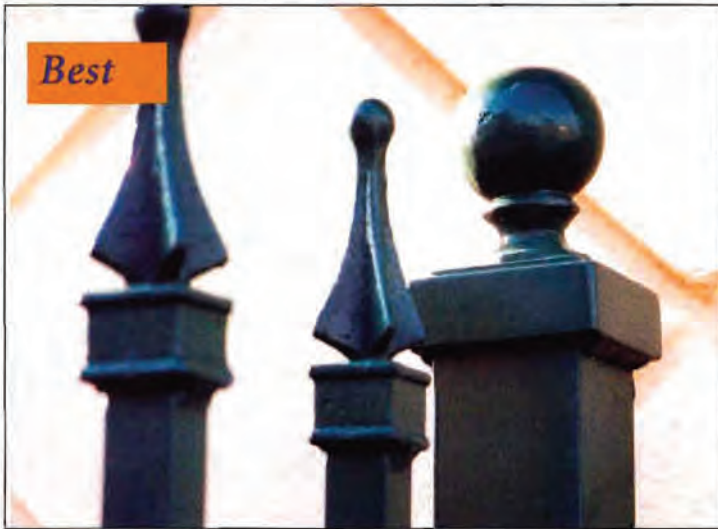
This marine grade and well powder coated spear and ball cap located just 100 yards from the ocean is in excellent, coherent condition after 3 1/2 years.

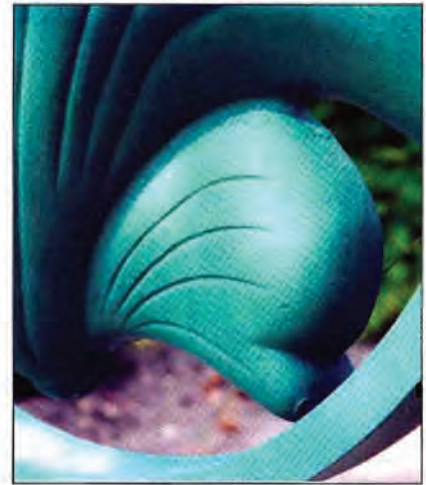
This marine grade large, heavy seashell aluminum casting adorning an exterior fence located between the Intracoastal Waterway and the Atlantic ocean shows a coherent coating in excellent condition after two years.
